**IGLOO AND REVETMENT
TESTS**

NAVAL PROVING GROUND, ARCO, IDAHO

OCTOBER, 1946

Army-Navy Explosives Safety Board 2029 Tempo 2 Building
Washington, D. C.

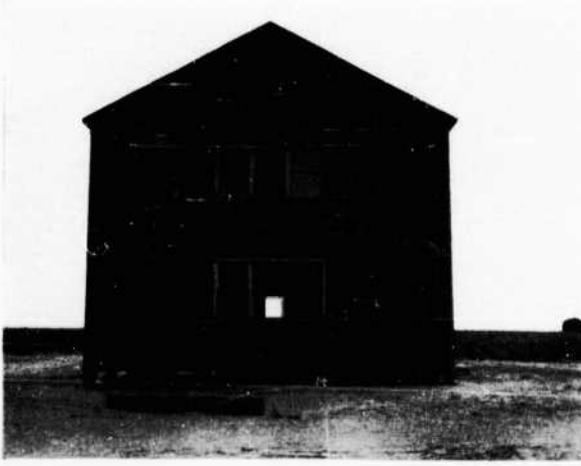
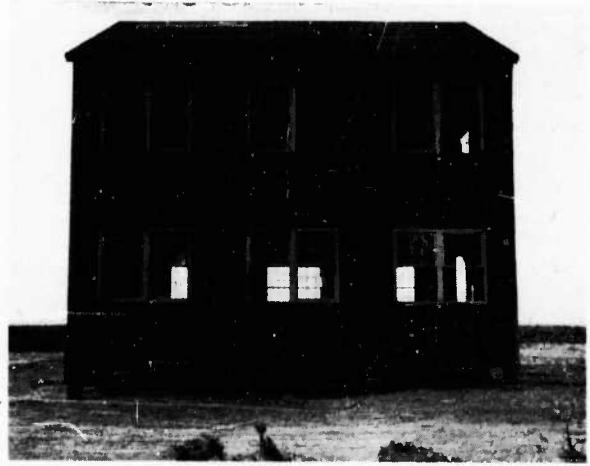
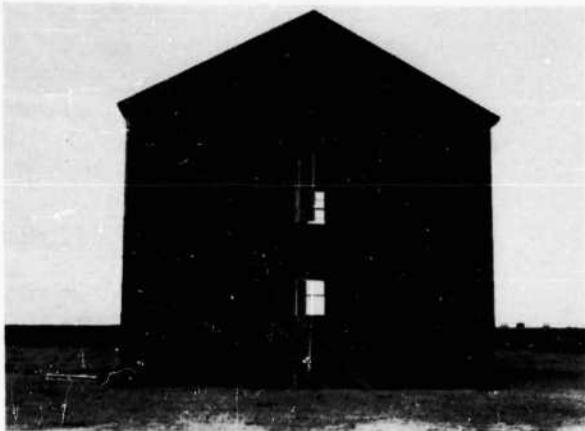
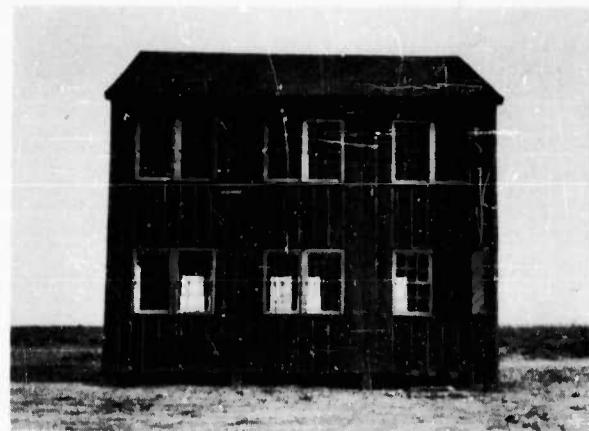
FIGURE 155. North elevation of Barracks 2 after Test 3

FIGURE 156. East elevation of Barracks 2 after Test 3

FIGURE 157. South elevation of Barracks 2 after Test 3

FIGURE 158. West elevation of Barracks 2 after Test 3

Barracks 2 was not repaired prior to the third test. On the north face, a large piece of siding which had been started in the previous blast was torn off. Additional exterior trim was broken around the windows and one sash which had been left leaning inward after test 2 was now missing from its frame. The east and south elevations did not receive additional superficial damage, but on the west side the southernmost window on the ground floor was blown out and lay on the ground outside. On the roof, there was no further tearing of asphalt felt roofing. The external appearance of the building is shown by figures 155-158.

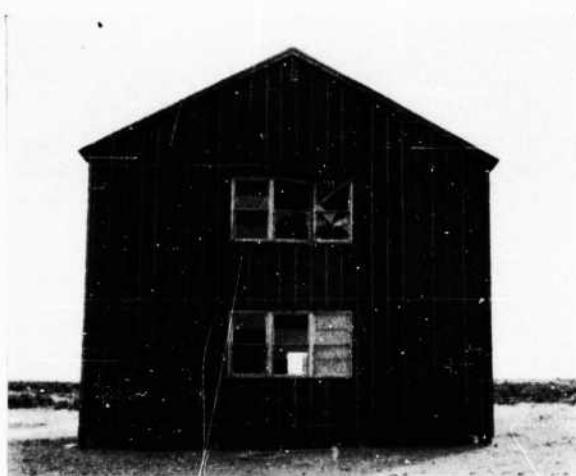
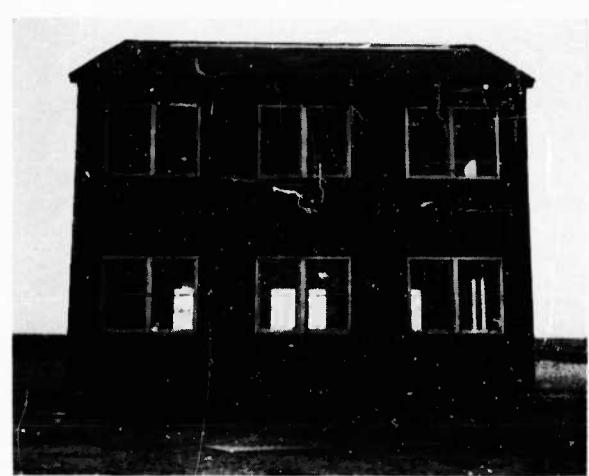
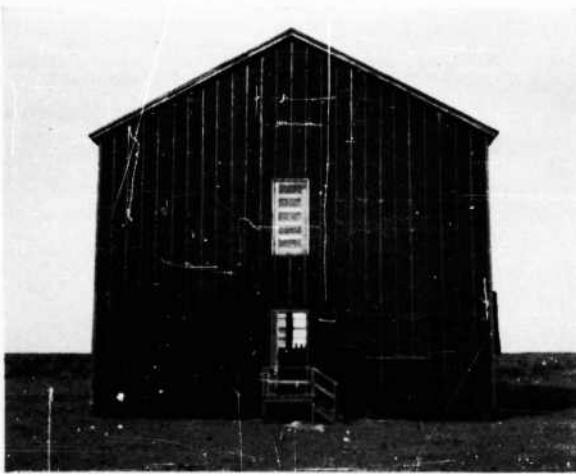
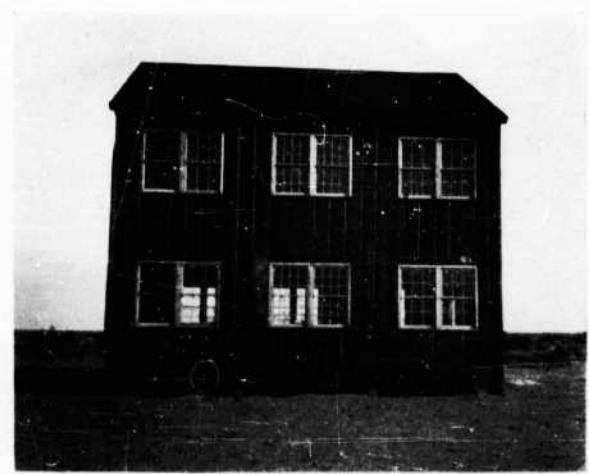
FIGURE 159. North elevation of Barracks 3 after Test 3

FIGURE 160. East elevation of Barracks 3 after Test 3

FIGURE 161. South elevation of Barracks 3 after Test 3

FIGURE 162. West elevation of Barracks 3 after Test 3

Barracks 3 was not damaged further except for a single tear in the siding on the east elevation and some increase in inward displacement of second story windows in the north elevation. Figures 159-162 illustrate the appearance of the building following the third test.

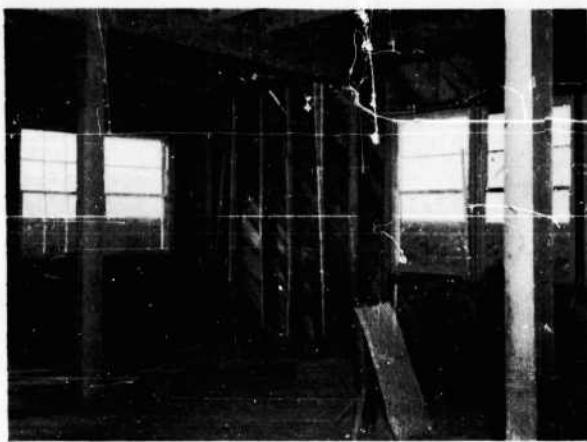
FIGURE 163. Interior, Barracks 1 after Test 3, showing broken studding, northwest corner, ground floor

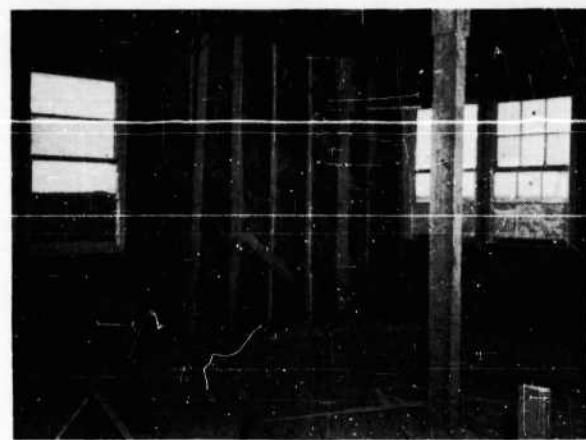
FIGURE 164. Interior, Barracks 1 after Test 3, showing broken studding, northeast corner, ground floor

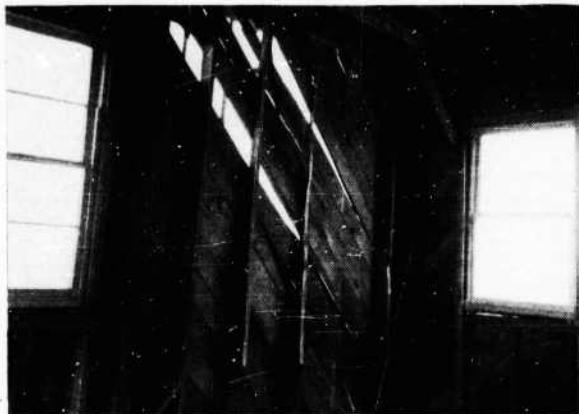
FIGURE 165. Interior, Barracks 1 after Test 3, showing condition of northeast corner, 2nd story

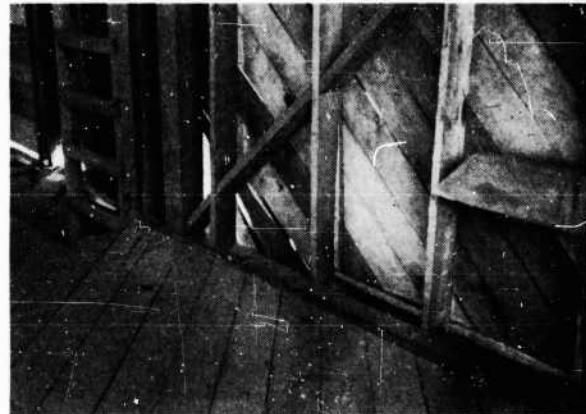
damage, but the south wall was pushed outward from within in the same manner as in the previous explosion. The maximum displacement was 6 inches, and occurred at the second floor level about 10 feet east of the west corner of the building. Figure 166 shows how the wall moved out, carrying the studs off the lower plate and fracturing the latter member. Siding was broken where it was racked between studs that moved out and the 6" x 6" posts that remained in position. One of these posts on the ground floor was leaning in about 3 inches at its top. The roof of the building suffered no further damage, but a piece of the previously fractured roof girder fell down on the ceiling joists, as shown by figure 167. There was no evidence that the entire building rocked or shifted on its foundation posts. See figure 168 for a diagram of the damage.

FIGURE 166. Interior, Barracks 1 after Test 3, illustrating displacement of south wall at second floor level

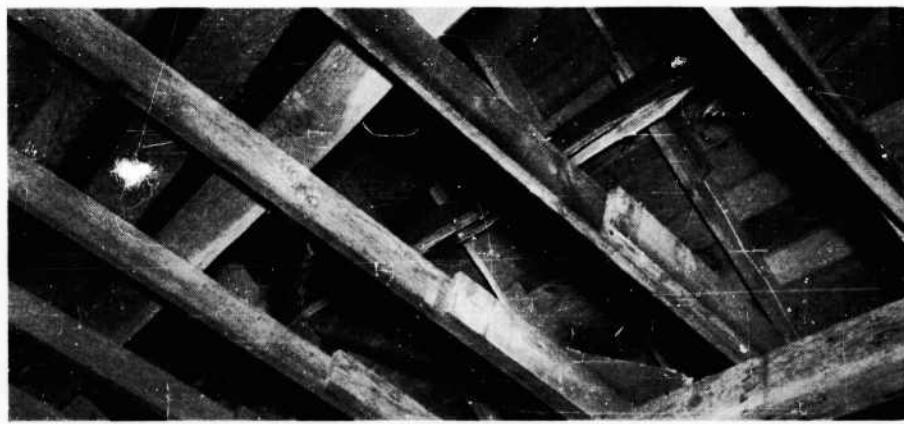
FIGURE 167. East section of roof framing, Barracks 1 after Test 3, showing broken purlin

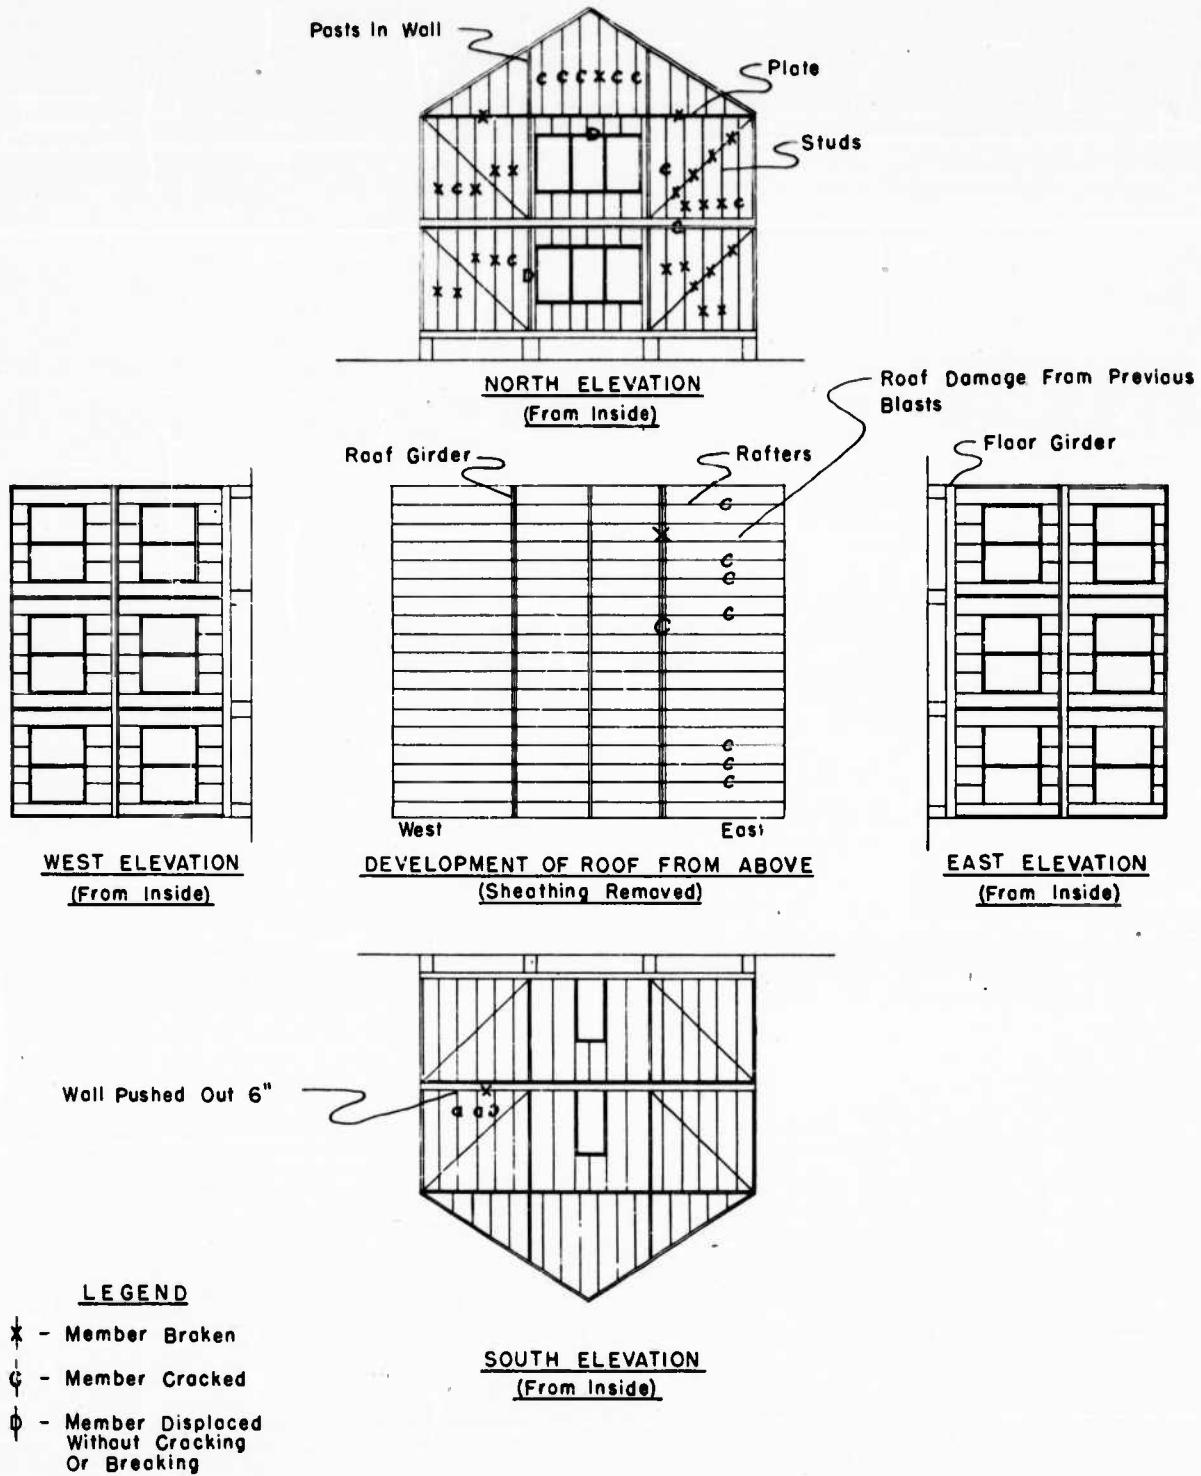
FIGURE 168. Damage to Barracks, Barracks 1, Test 3

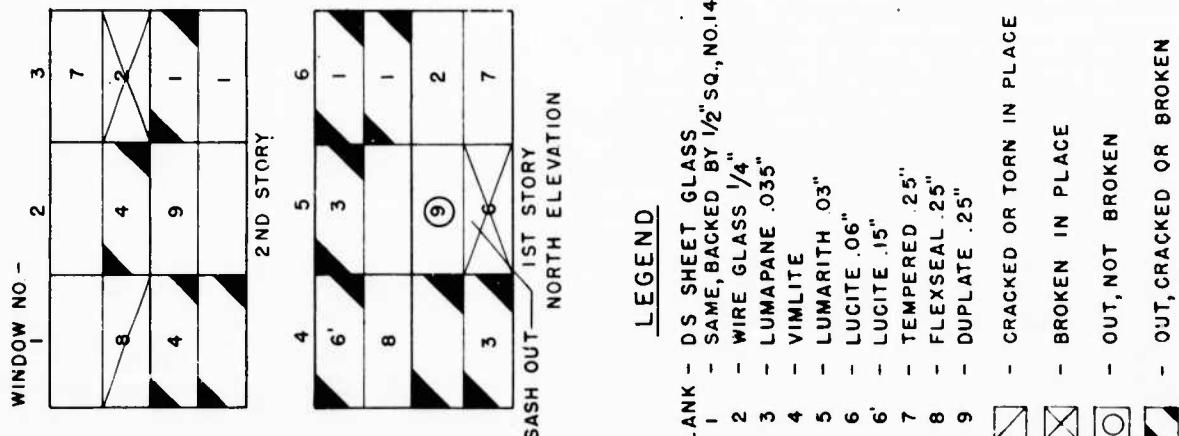
(3) *Glass damage.*—*Barracks 1*, which had been completely reglazed, suffered glass damage as recorded by figure 169. Thirteen, or one more than half the panes were broken on the north side. Sixty-four, or 36 percent were broken in the windows on the east side. The upper sash of window 22 in the second story was freakishly demolished without all of its panes being broken. None of the panes on the west side of the building were broken. Although the window breakage was not as violent as in test 1, and fewer sash were blasted out of their frames, there was nevertheless considerable flying glass as evidenced by fragments scattered over the floors of both stories. Most of the pieces were propelled with sufficient force to carry them about two-thirds of the distance across the interior of the building, so that any occupant of the building would have been in considerable danger of injury.

FIGURE 169. Glass Damage, Barracks 1, Test 3

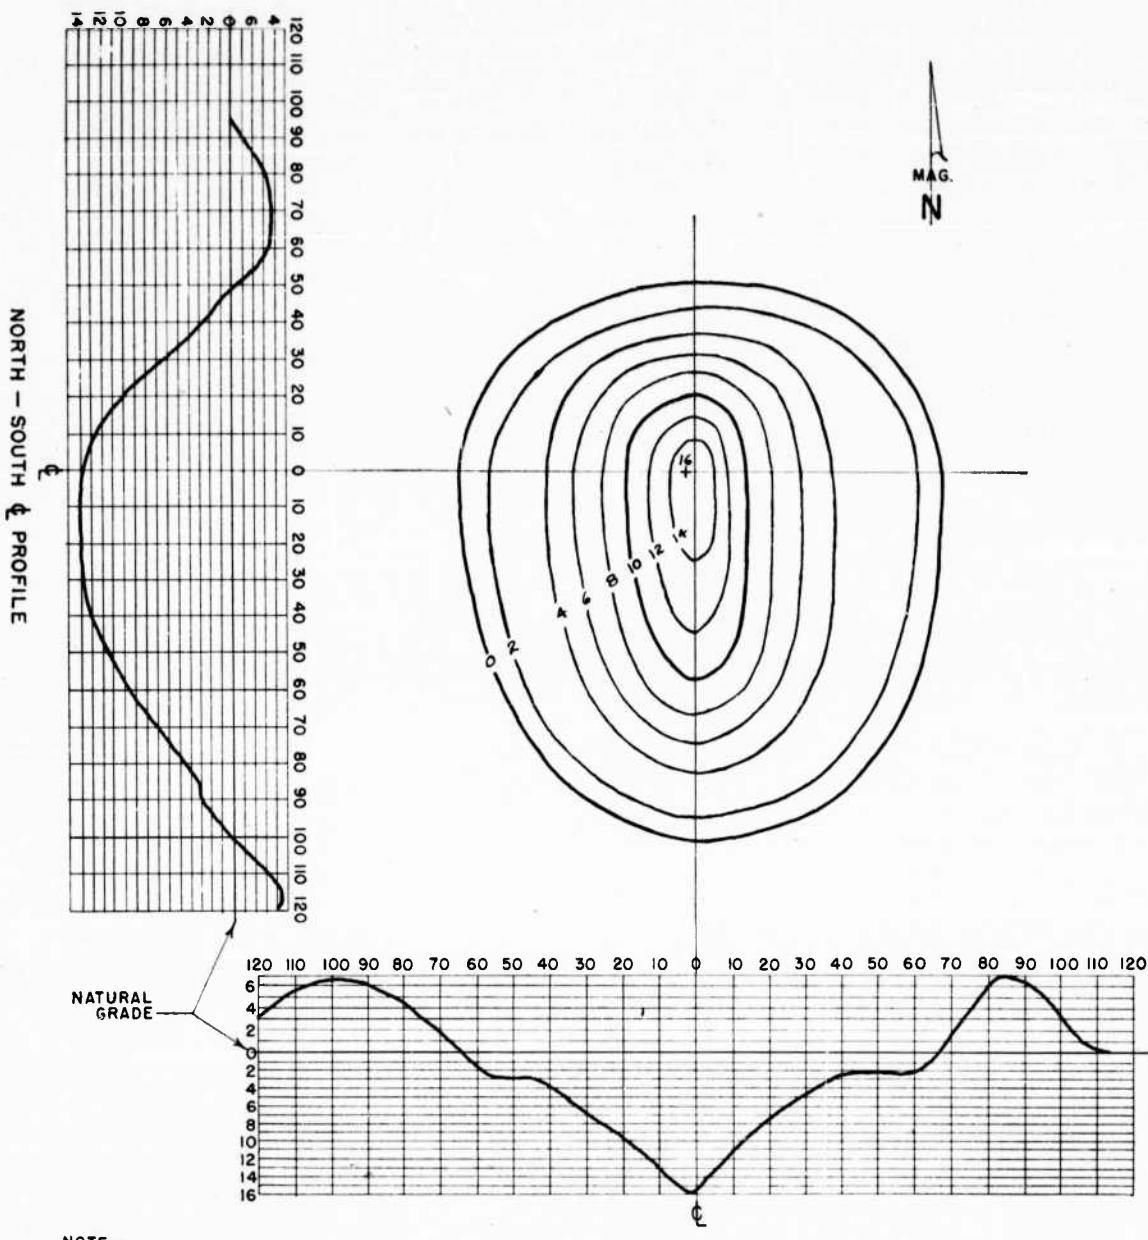
FIGURE 178. Crater Plan and Profiles, Test 4

(d) *Crater*.—Profiles along the north-south and east-west axes are given by figure 178. The average apparent diameter was 138 feet, and the maximum apparent depth was 16 feet. This crater was more truly conical in shape than those of the igloo tests; the sides sloped more or less uniformly to the deepest part, which was close to the center. While quite symmetrical with respect to the east-west axis, the crater was not so with respect to the north-south axis, its center being about 15 feet south of the lateral axis of the stack of mines. The earth in this crater was nearly devoid of debris, and presented an appearance markedly different

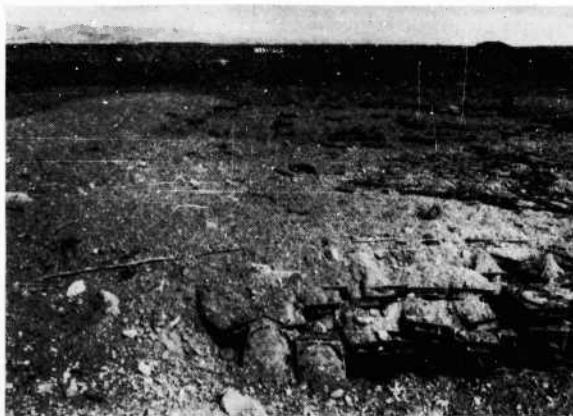
(f) *Damage to Revetment 2.*—Figures 181 and 182 show the appearance of this revetment following the fourth explosion. Mines thrown outside of the revetment in the previous test had been replaced. In this test they were not as severely scattered but merely shaken up and displaced without being thrown violently from the pile. Some additional earth descended on the stack.

FIGURE 181. Revetment 2 after Test 4, looking north from south windrow

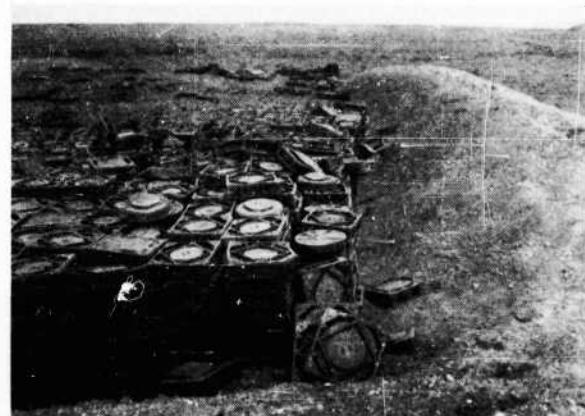
FIGURE 182. Revetment 2 after Test 4, looking north from southeast corner

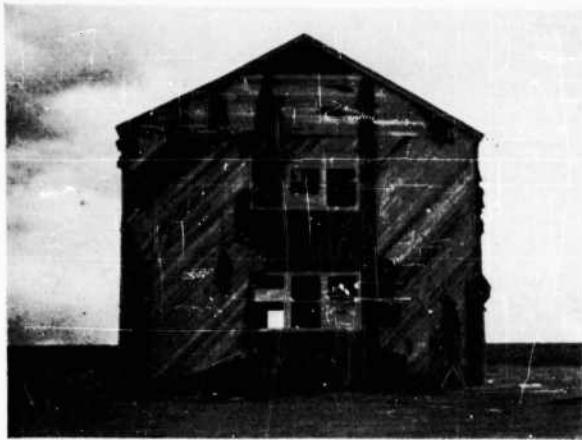
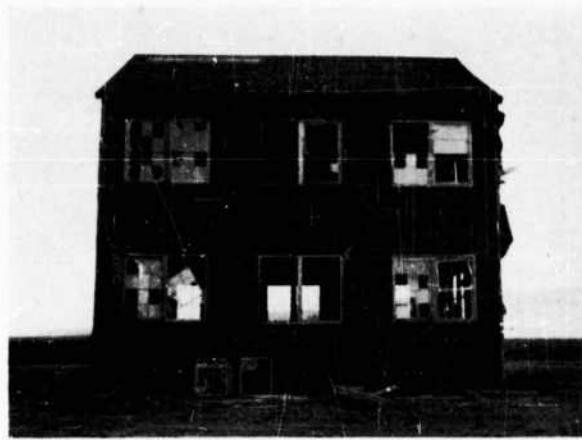
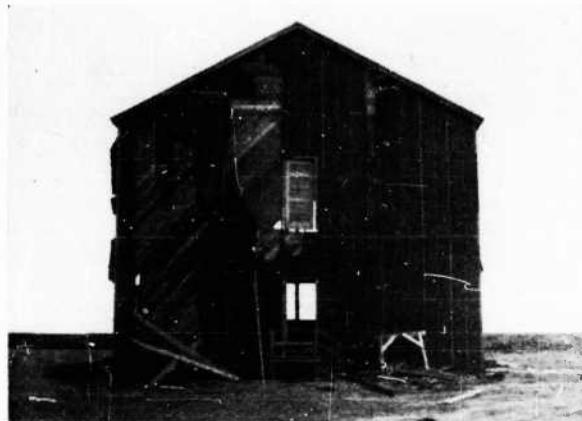
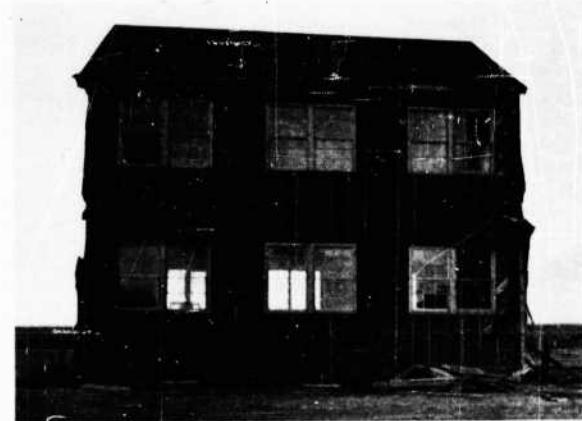
(g) *Damage to barracks:* (1) *Superficial.*—Barracks 1, not having been repaired prior to this test, lost nearly all of the remaining asphalt felt siding and battens on the north elevation, to the extent that about 90 percent of the sheathing was uncovered. Another sash was blown into the building from the upper story windows on the north side. On the east eleva-

tion, a few previously torn spots in the siding were made worse, five additional sash were blown in and one left hanging askew. Further damage was done to exterior window trim. On the south face, torn siding now exposed about one-third of the sheathing, and parts of the second-story door frame and trim were broken and missing. The west elevation lost a little more siding at the south end of the building

and the muntins were broken out of two upper-story sash. The four elevations of the building are shown in figures 183-186.

FIGURE 183. Barracks 1 after Test 4;
north elevation

FIGURE 184. Barracks 1 after Test 4;
east elevation

FIGURE 185. Barracks 1 after Test 4;
south elevation

FIGURE 186. Barracks 1 after Test 4;
west elevation

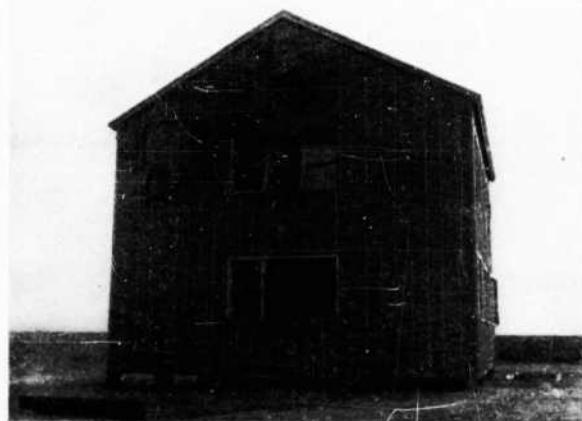
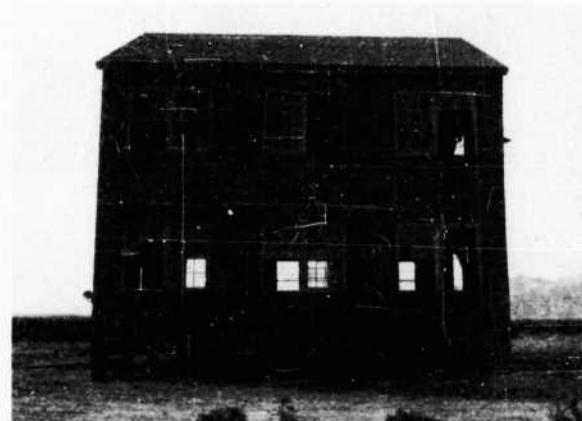
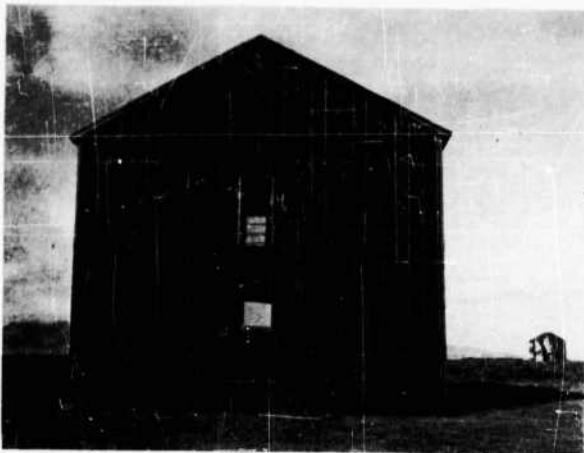
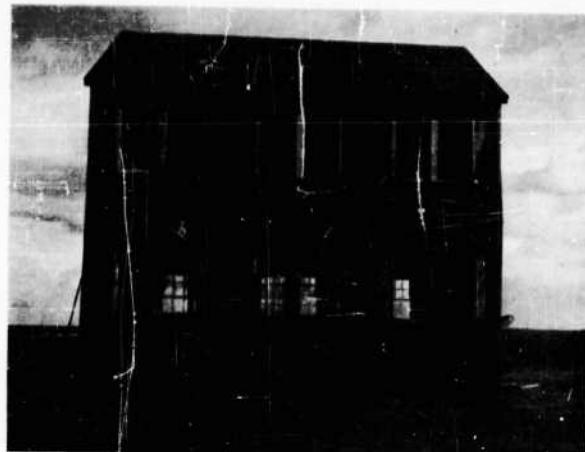
Barracks 2 suffered a large tear in the siding on the north gable. The upper-story windows in the north wall were displaced inward further but not blown completely out of their frames. On the east side, one additional sash was blown in on the ground floor, and one of the upper

windows lost parts of its exterior trim. On the south elevation the upper-story door was blown out and there was a tear in the siding next to the lower-story door. There were two additional tears in the siding on the west side of the building. See figures 187-190.

FIGURE 187. Barracks 2 after Test 4;
north elevation

FIGURE 188. Barracks 2 after Test 4;
east elevation

FIGURE 189. Barracks 2 after Test 4; south elevation

FIGURE 190. Barracks 2 after Test 4; west elevation

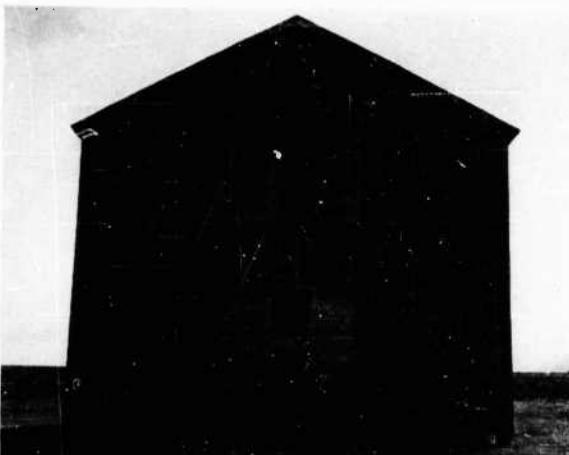
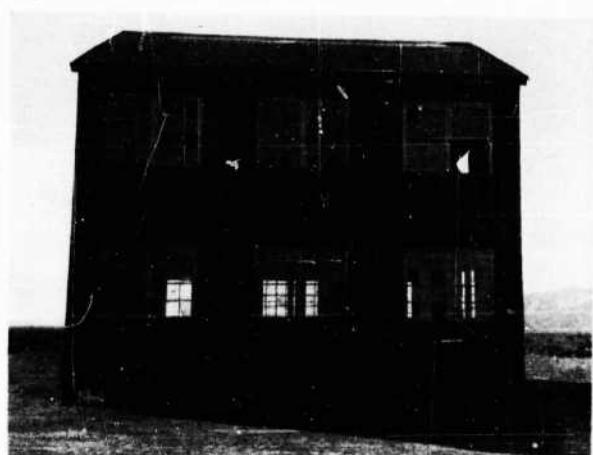
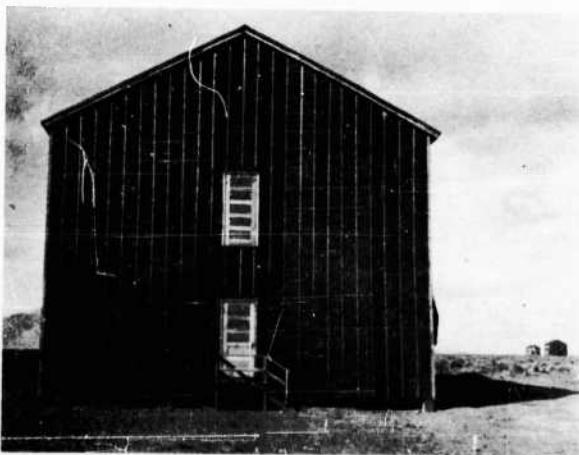
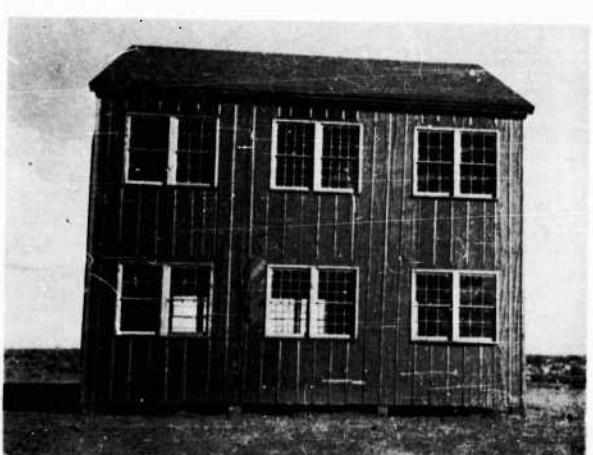
Barracks 3 did not receive further superficial damage except for a small amount of inward deflection of the upper windows in the north side, together with displacement of trim. See figures 191-194.

FIGURE 191. Barracks 3 after Test 4; north elevation

FIGURE 192. Barracks 3 after Test 4; east elevation

FIGURE 193. Barracks 3 after Test 4; south elevation

FIGURE 194. Barracks 3 after Test 4; west elevation

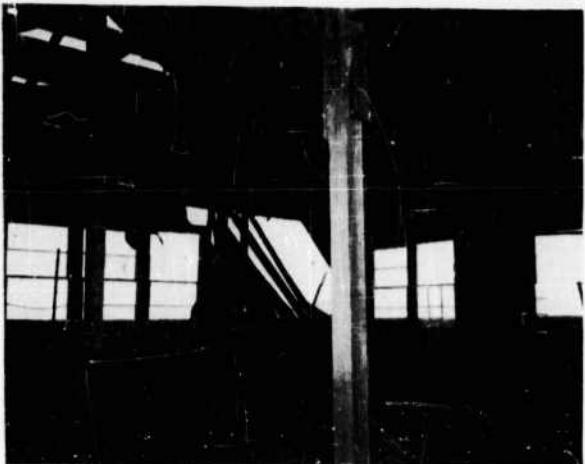
(2) *Structural*.—*Barracks 1* lost a number of sheathing boards on both the north and south sides, and most of the remaining were either fractured or displaced from position. The entire north wall bulged inward about a foot, while the south wall bulged outward a like amount. Practically all of the studs were either broken or out of place in the north wall, and about half the studs were in similar condition in the south wall. A 4" x 6" post in the south wall which had supported the end of a floor girder was knocked down, leaving the second floor hanging at this point. A few studs were cracked in the east and south walls, and a few more rafters were broken on the east side of the roof near the north end. Although damage was quite extensive, the building was in no danger of collapsing, inasmuch as the interior columns and the east and west walls were nearly intact, structurally. Typical scenes inside this building are given in figures 195 and 196.

FIGURE 195. Interior of Barracks 1 after Test 4,
looking toward northeast corner on second floor

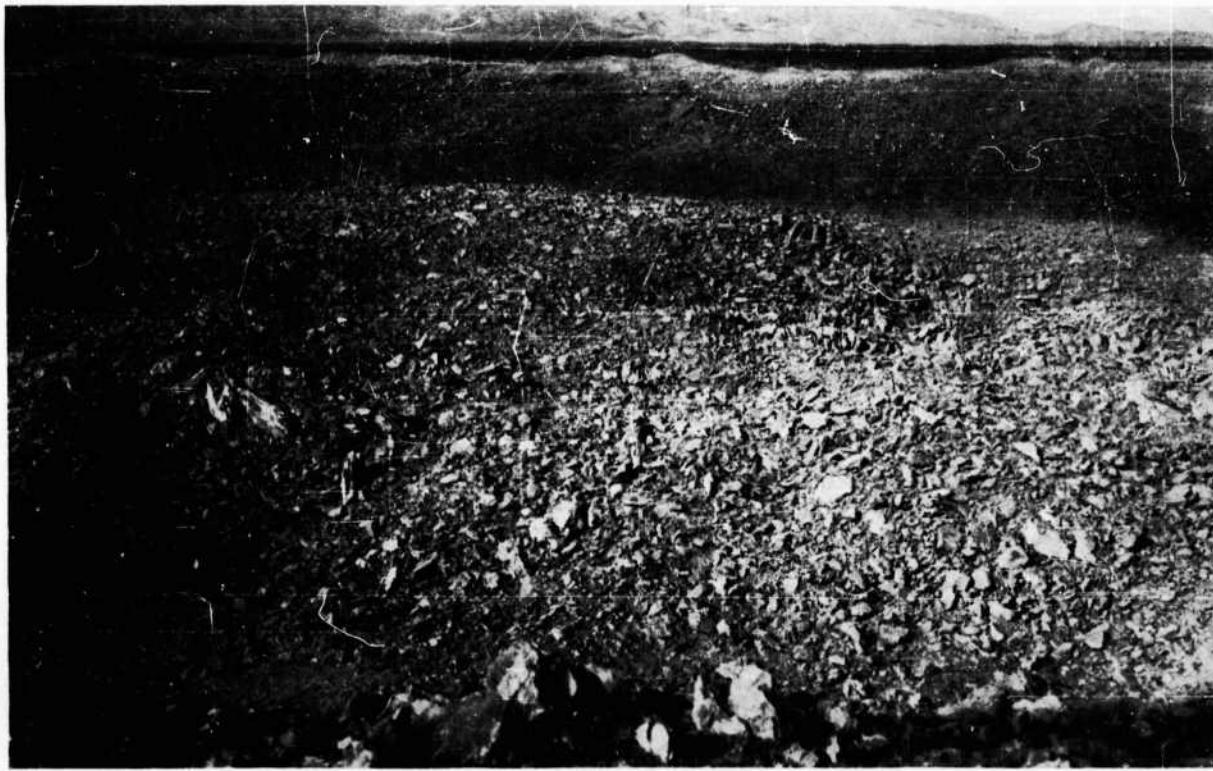
which characterized that in the crater of test 4, consisting of sharply broken clods of compressed fine-grained soil with a peculiar schistose structure. The clods were friable, however, and not indurated. Figure 203, a photograph of the crater looking westward from the east rim, illustrates the appearance of this soil.

FIGURE 203. Crater of Revetment 2, looking west from east rim

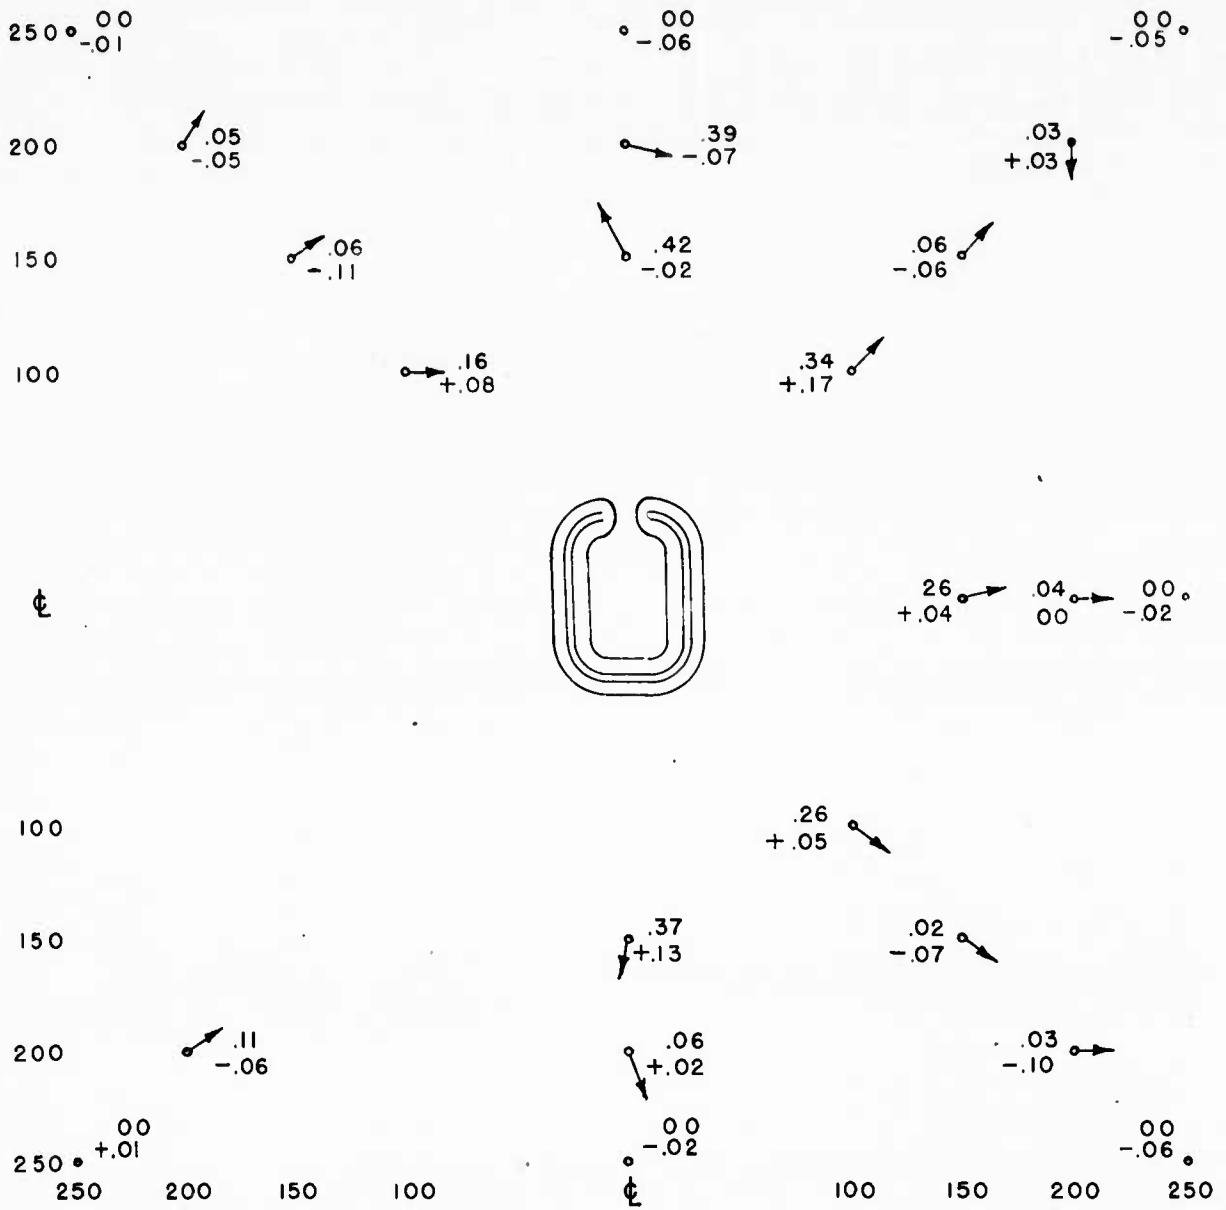
FIGURE 204. Permanent Horizontal and Vertical Earth Displacement Revetment No. II, Test No. 5

(c) *Ground movement*.—Figure 204 gives permanent horizontal and vertical displacements of the ground surface surrounding this explosion. Horizontal movement was predominately away from the center, and varied from 0.37' at 140 feet to zero at 250 feet. Vertical movement was mostly upward in close to the explosion but subsidence prevailed at 150 feet and beyond. Values ranged from 0.17' upward at 140 feet to a maximum downward movement of 0.07' at 200 feet, and a minimum downward movement of 0.01' at 350 feet from the center.

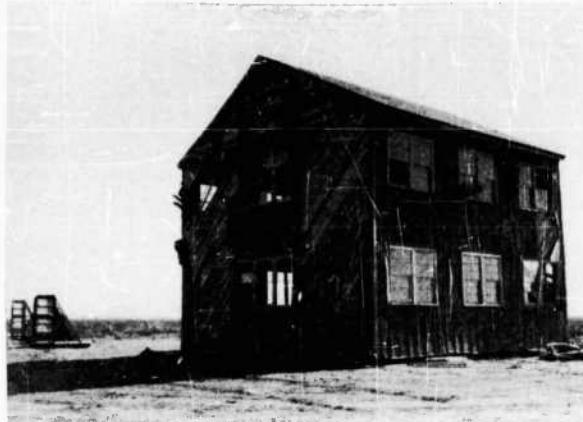
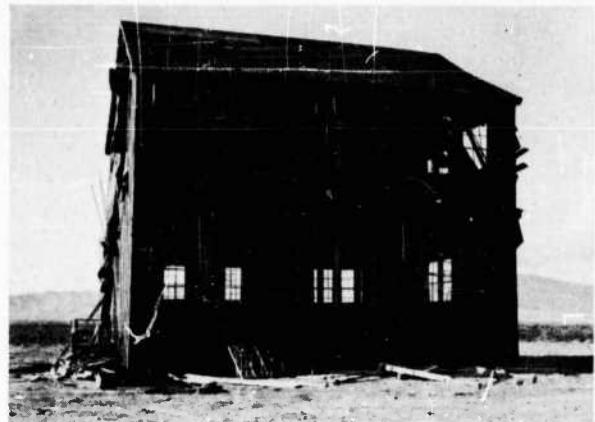
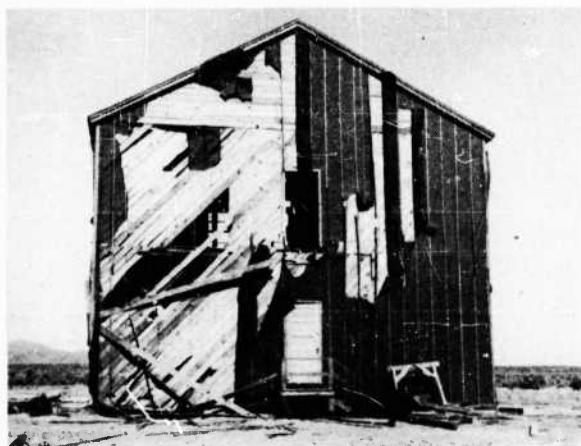
(d) *Damage to barracks:* (1) *Superficial.*—*Barracks 1*, another sash was blown in from one of the north windows, and there was a little more tearing of the asphalt felt siding on the north side. On the east elevation a sash which had been left hanging askew in the previous blast was now missing from its frame, and the siding on this side was torn a little more. The south elevation lost more siding to the extent that half the sheathing was uncovered, and the upper story door was blown out. On the west side, there was further tearing of siding and a previously broken upper sash was blown in from one of the second-story windows. For photographs of the elevations, see figures 205-207.

FIGURE 205. North and west elevations of Barracks 1 after Test 5

FIGURE 206. East elevation of Barracks 1 after Test 5

FIGURE 207. South elevation of Barracks 1 after Test 5

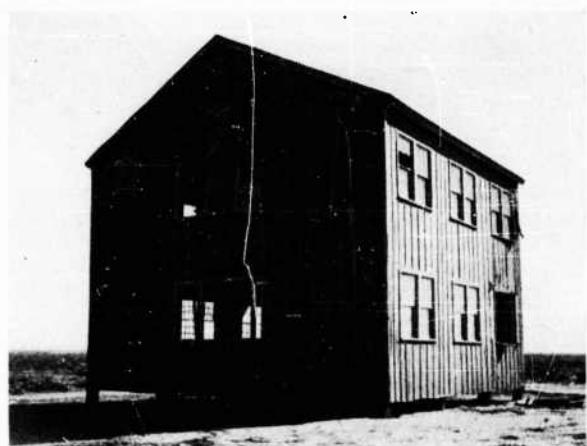
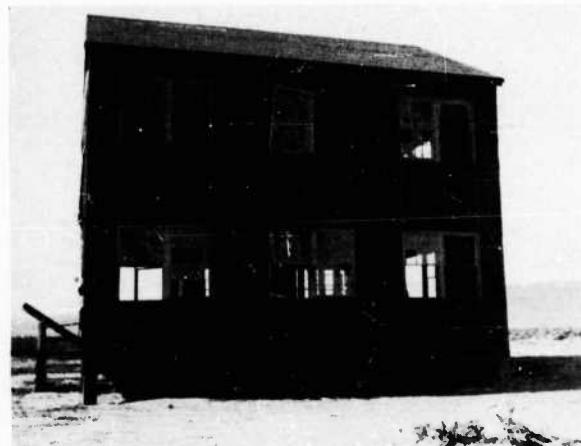
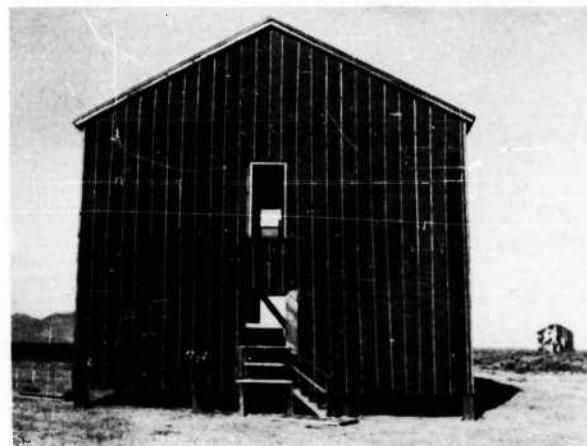
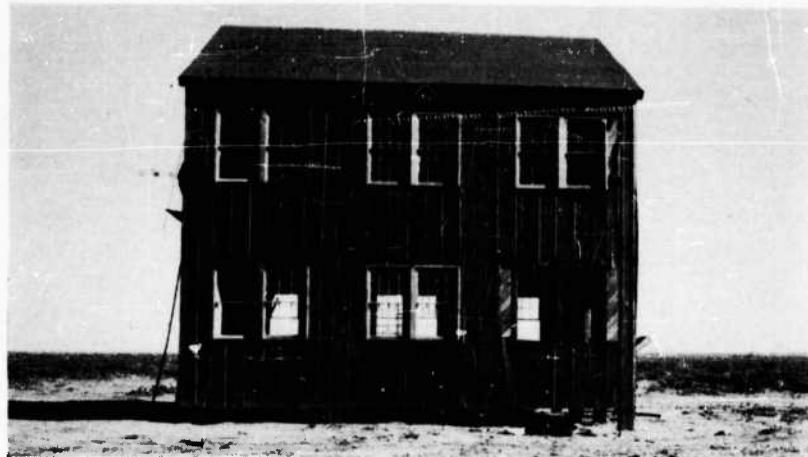
Barracks 2, a little more siding was gone in the north gable and alongside the door in the south elevation. Another sash was missing from one of the north windows. Figures 208-211 are views of the four sides of the building.

FIGURE 208. North elevation of Barracks 2 after Test 5

FIGURE 209. East elevation of Barracks 2 after Test 5

FIGURE 210. South elevation of Barracks 2 after Test 5

FIGURE 211. West elevation of Barracks 2 after Test 5

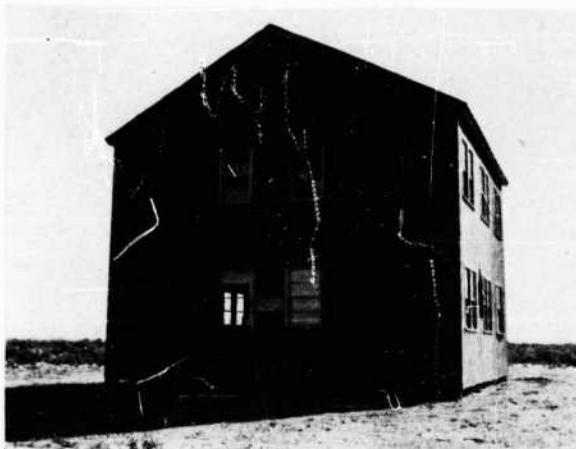
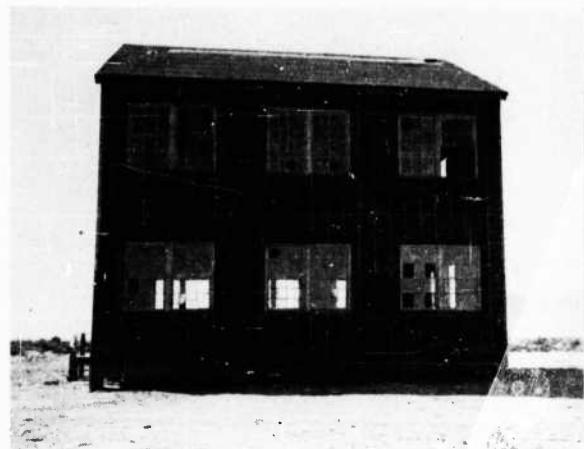
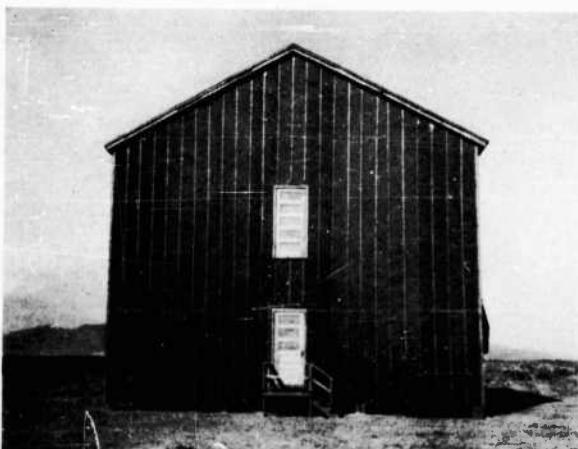
Barracks 3, figures 212-215 show that there was no appreciable further damage, other than a loose sash falling to the ground from an upper-story window in the north wall.

FIGURE 212. North elevation of Barracks 3 after Test 5

FIGURE 213. East elevation of Barracks 3 after Test 5

FIGURE 214. South elevation of Barracks 3 after Test 5

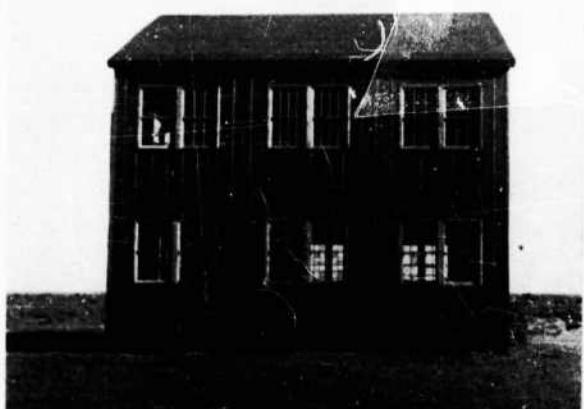
FIGURE 215. West elevation of Barracks 3 after Test 5

Barracks 3, no further glass damage.

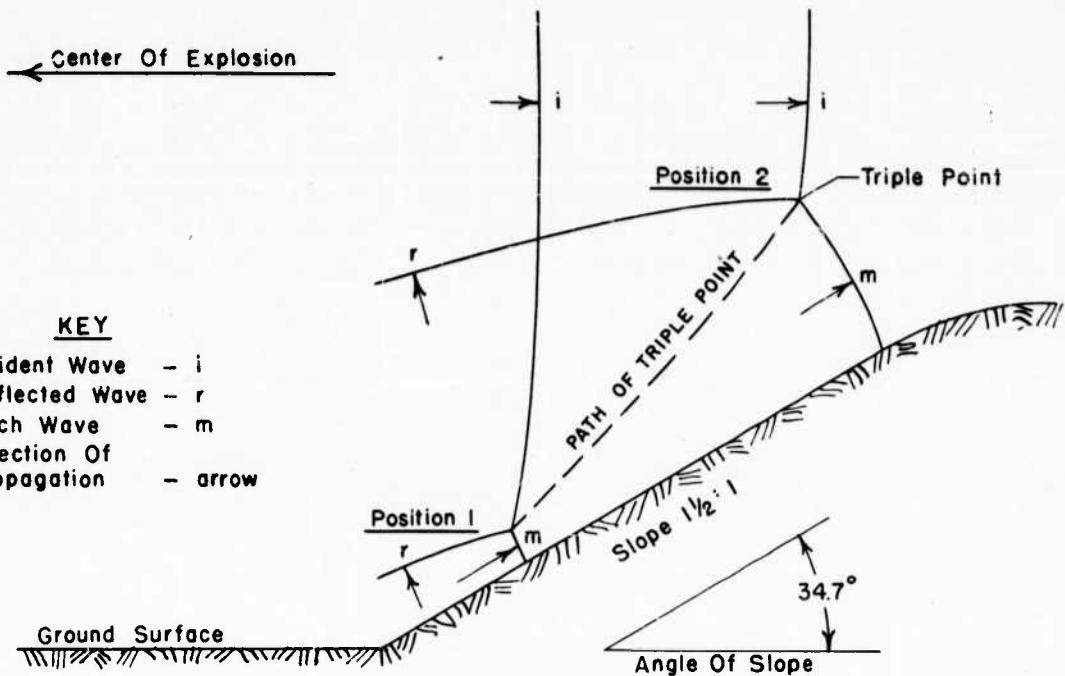
FIGURE 223. Mach reflection on sloping earth embankment of target igloo

(2) *Mach reflection*.—As previously stated, a Mach reflection took place when the shock wave impinged on the sloping embankment of Igloo E in the first test. The triple point, or intersection of incident, reflected, and mach waves, appeared to form at the bottom of the slope and followed a characteristic rising path as it progressed up the slope. The relation of the three waves to one another and their directions of propagation are illustrated by figure 223, which shows the phenomena more clearly than any of the photographs. When a Mach reflection takes place, pressures on the reflecting plane may be several times the hydrostatic

value. The increase in pressure depends upon the angle of incidence of the wave on the plane. Under the conditions obtaining in the first test, the overpressure on the earth slope of Igloo E was of the order of 6 times normal atmospheric pressure at that distance, or about 62 p.s.i. instead of between 35 and 45 p.s.i. hydrostatic pressure behind the incident wave front. The angle of slope of the earth cover ($1\frac{1}{2}:1$) is rather favorable and avoids the extreme over-pressure ratios of up to 10 or 12 which would occur on steeper slopes. The critical angle of slope in this test would have been about 54 degrees. Flatter slopes, of course, would decrease the overpressure, the lower limit being the "side-on" or hydrostatic value.

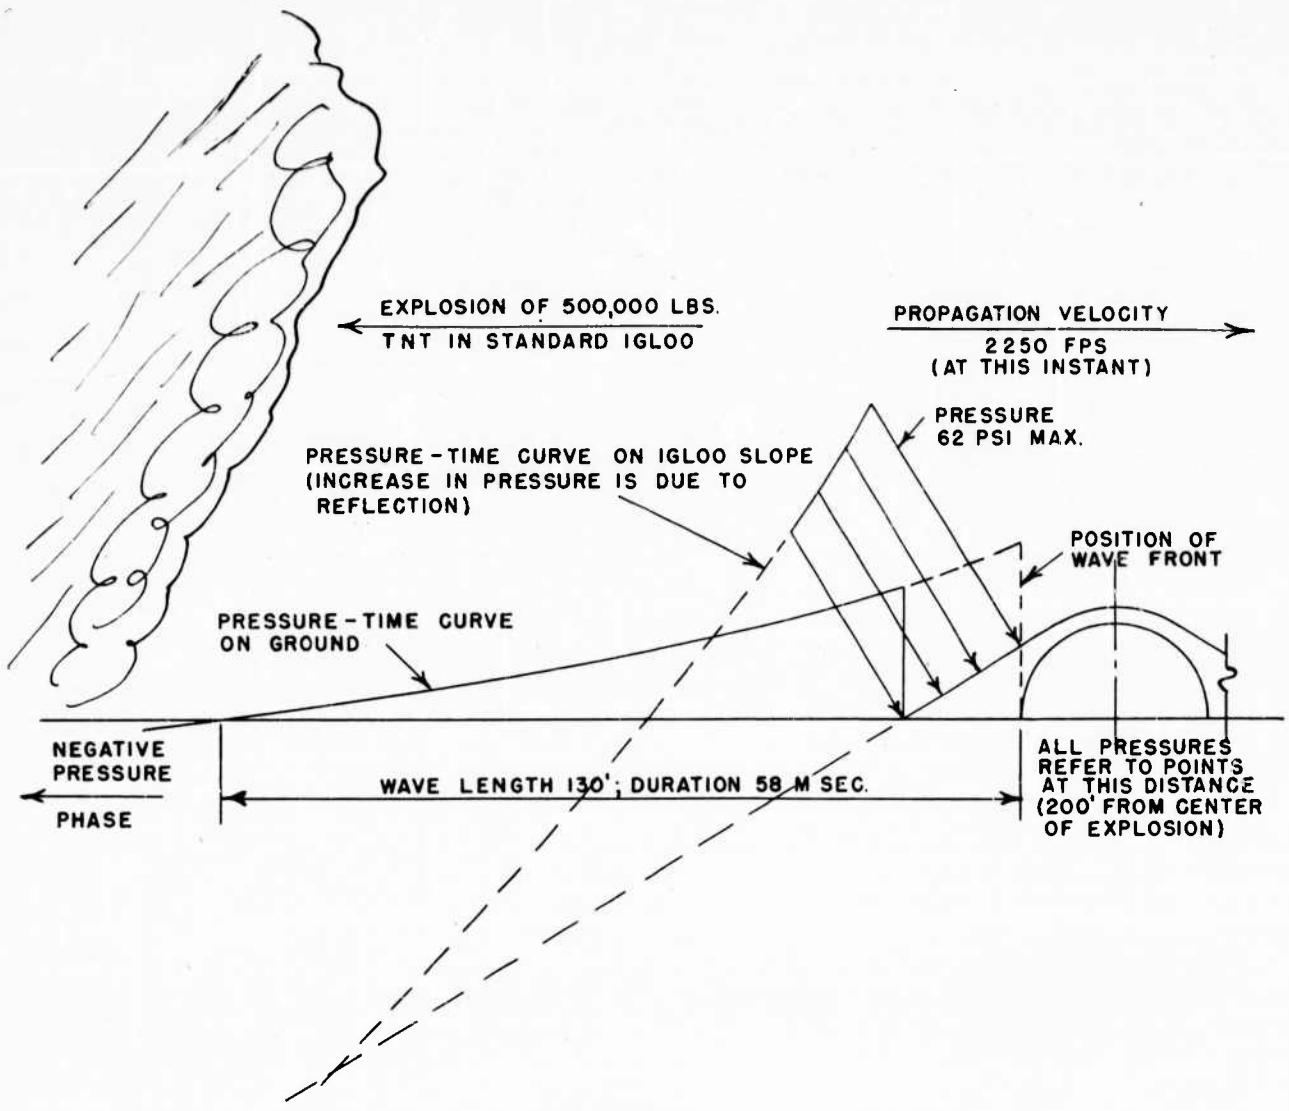
FIGURE 224. Blast loading on near side of igloo

(3) *Blast loading on target igloos*.—From the foregoing information and the duration of the positive phase of the blast wave of 58 milliseconds at a distance of 200 feet from the center of an explosion of 500,000 pounds, determined from the equation presented in the Woods Hole report (Sec. IV-B) it is possible to construct a diagram, figure 224, approximately representing the positive pressure-time loading on the near side slope of a standard igloo in the event of an explosion of its next-in-line neighbor containing 500,000 net pounds of high explosives. This diagram does not represent conditions on top or on the lee side, because of differences in reflection and diffraction effects; however, it would probably be conservative to apply it over the entire igloo in design. Pressures indicated are for a distance of 200 feet. As the wave passes across the igloo, the pressures decrease, while the duration and wave-length increases. Pressures are believed to be considerably attenuated in passing through the earth cover to the surface of the concrete. The negative phase is not shown because the maximum negative pressure is only from about one-half to one-fifth of the peak positive value. The negative duration is several times the positive duration, however.
